HUMAN FACTORS STUDY OF QMC CLOTHING AND EQUIPMENT DURING COLD WEATHER TESTS OF THE PERSHING MISSILE SYSTEM

John M. McGinnis, et al

Quartermaster Research and Engineering Center Natick, Massachusetts

April 1962

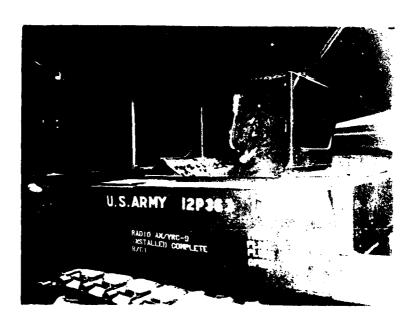
Fig. 5. Driver's station in the XM474 Tracked Vehicle

headgear did not interfere with observation of the displays. However, it is possible that the winter hood with fur ruff may interfere somewhat with the driver's view to either side when the vehicle is in motion. As the XM474 vehicles were stationary during nearly all the test there was little opportunity to evaluate this point. For this reason, it should be carefully checked during cold weather field tests of the system.
